INTERNATIONAL WHEELSET CONGRESS

14th

RESEARCH OF THE STRUCTURE CHANGES CLOSE TO THE TREAD SURFACE OF THE RAILWAY WHEELS DURING OPERATION

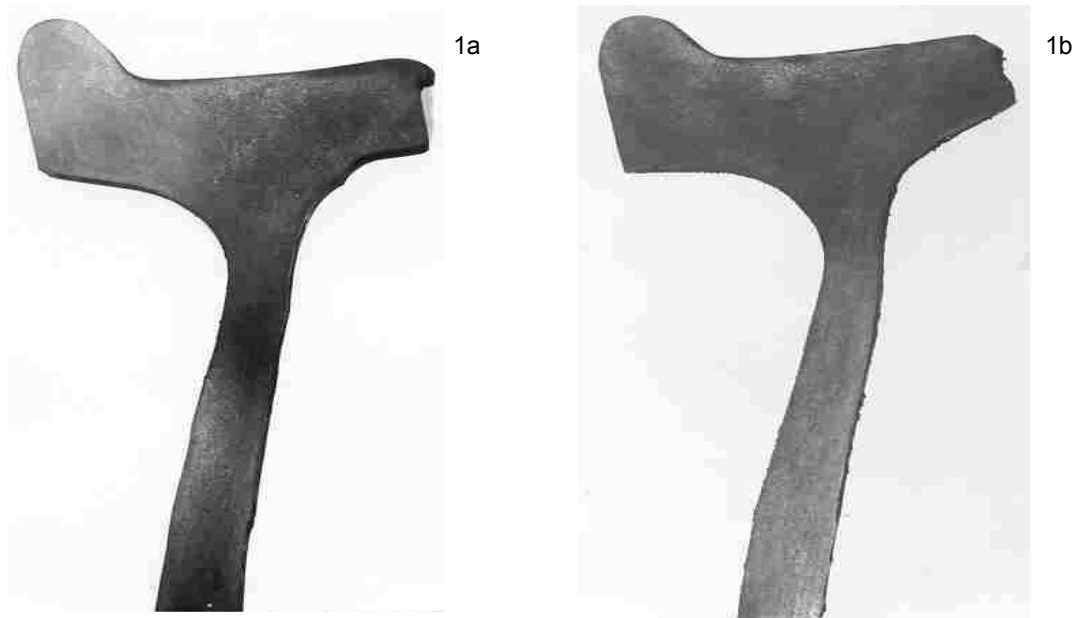
The cross – section templates were cut from the wheels and on the section the character of their structure in the width of the rim was studied. Microstructural analysis was carried out on the optical microscope “Neophot-21”. The peculiarities of the steel fine structure and locations density in the superficial layer were determined with the help of the electronic-microscopic (transmission microscope “Tesla”) and X-ray structure analysis. Visually inspected wheel # 1 with the badly worn flange had revealed on the tread the defects like creep, metal galling, liquation, buildup of the steel from the tread to the outer side face of the rim, fatigue – corrosion wear. The buildup of the steel resulted in the distortion of the wheel profile during operation (fig. 1a). From the creep to the deeper layers of the rim the numerous cracks initiated accompanied by the steel bearing zone and corrosion of the steel. Microstructure analysis of the cross-section template of the wheel #2 with the complex-curvilinear tread did not reveal any distortion of the profile (fig. 1 b). On the surface there is a small creep, the traces of corrosive destruction and small buildup of the steel to the outer side face of the rim.

Fig. 1. Macrostructure of wheels # 1(a) and 6 (b) with worn rim

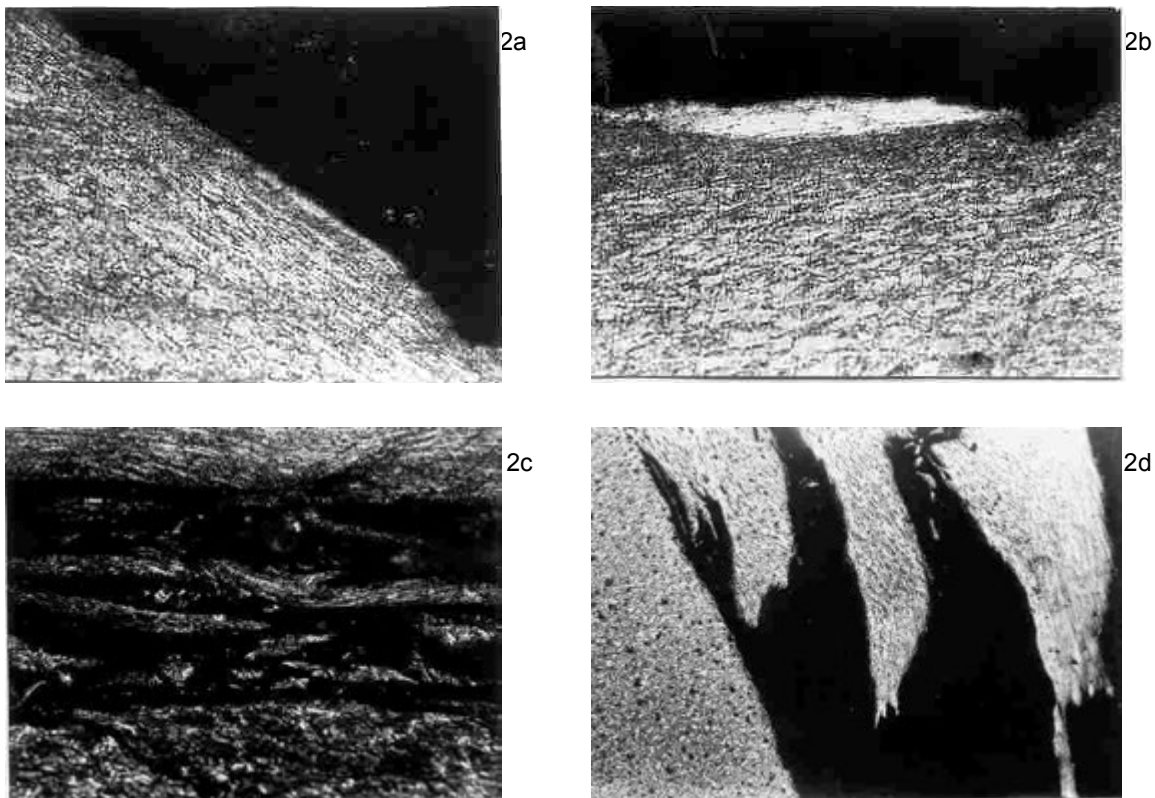
In coving zone of wheel #1 the grains are greatly elongated and grinded (fig. 2a), approaching the tread the grains are bigger, their elongation degree is slightly reduced and becomes progressively less while going inside the tread (fig. 2b). While moving off the middle part of the tread to the opposite side to the flange elongation degree of grains grows again and becomes significant by the edge of rim. The nature of the structure in this part of tread is evidencing substantial steel flow in this zone, leading to wheel profile change. In flow zone laminations are discovered, oriented parallel to the tread (fig. 2c). As a rule they are located at the border in between areas with sharply different microstructure and divide the zones of elongated and equiaxial grains. The flow occurred progressively, by layers, which were warped while their displacement. At the same time fatigue cracks appeared, promoting metal corrosion in layers. At the very edge of the flow to the side rim surface the lobes with deformed structure overhang (fig. 2d). They are also the evidence of fiberwise flow device. Between these layers and also between floating metal and side edge cracks are visible.

Fig. 2. Microstructure of different areas of worn tread of wheel 1; x200

The areas of “white layer” are structureless martensite (hardenite), it is a fatigue structural component, which is crumbled in the process of wheel service (see fig. 2b). “White layer” appears as a result of warming of thin surface layer of breaking heat till temperature beyond A_3 and subsequent quenching after break-shoes are switched-off. The width of “white layer” is 20-40 μm .

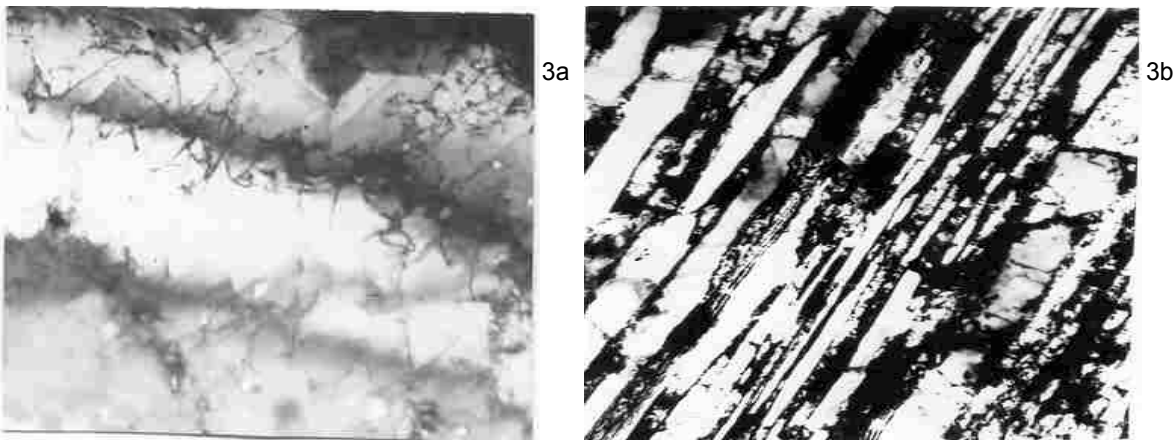
It should be noted that at operation on tread in conditions of deformative processes at rolling friction textures of rolling are formed, which are materialized as a result of joint action of normal and contact stresses. The examples of such textures, which are discovered in wheel #1 and then in the other wheels with cone-and-plate profile of tread: $(223) [03\bar{2}]$, $(212) [\bar{5}2\bar{6}]$, $(112) [\bar{1}\bar{3}\bar{2}]$, $(221) [1\bar{1}\bar{1}]$. In steel layer on the tread typical dislocation cellular substructure is shaped with gentle orientation of cellular webs towards the friction direction – band-pass substructure (fig. 3). Physical spreading of lines (110) is modified by depth from tread, which is related to different thickness of dislocations.

Fig.3. Dislocation substructure of steel near tread; x20000

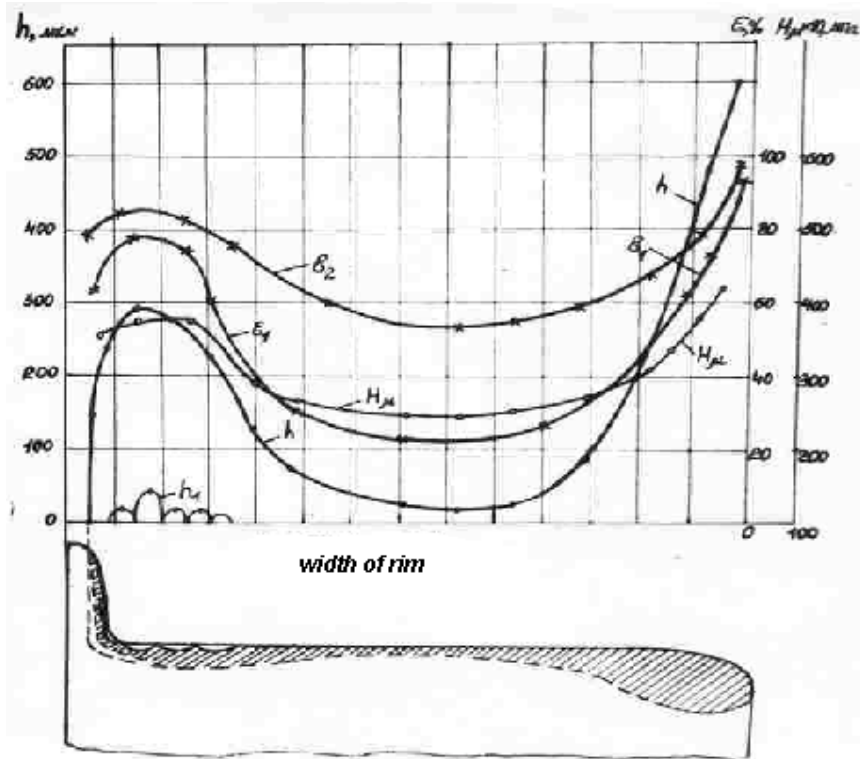
The depth of zone of deformed grains edgewise of tread of wheel #1 is unequal (fig. 4). Plastic deformation spread innermost in flange cove area and in flow area near the rim edge. Elongation degree of grains allows to judge deformation degree of steel in surface coating of rim. The patterns of change of microhardness are similar. Dislocations thickness, defined by X-ray structure analysis is also unequal in different areas of tread. The allocation on the rim profile of parameters of intensive deformation of metal coating is indicated on fig. 4. Microhardness splashes were observed in the areas of occurrence of “white layer” structure.

Fig. 4. Changing of deformation rate of grains across ϵ_1 and in rolling direction ϵ_2 , microhardness H_μ and depth of plastic deformation area h in the width of wheel rim 1

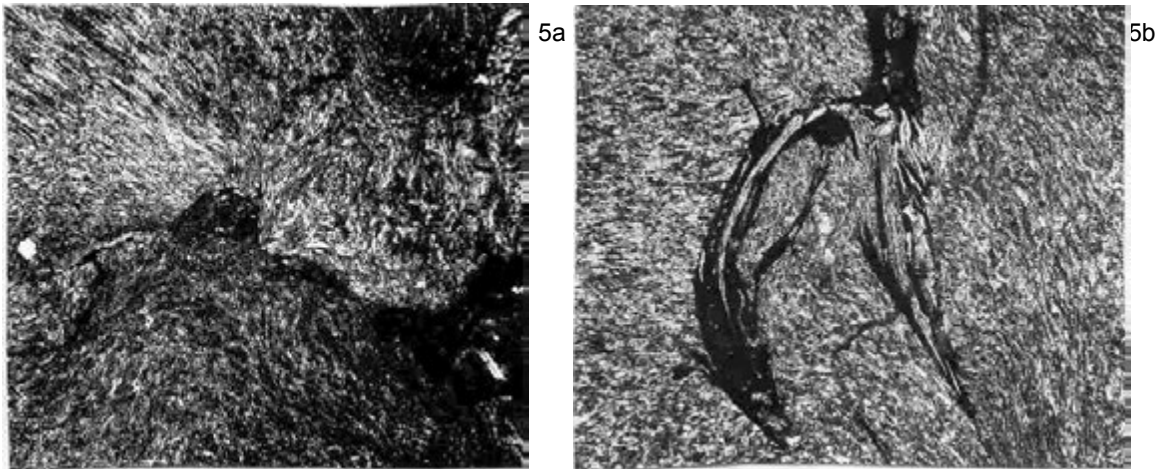
Microstructure nature of wheel #1 near tread in rolling direction is similar as for cross section considered above, however, elongation degree of grains in longitudinal direction is significantly higher. During analysis of structure in plate of rolling complex mode of steel stream is discovered in surface coating (fig. 5). There are areas with bent and curled grains in flow zone, where steel stream beard obviously rotational, turbulent nature.

Fig. 5. Microstructure of worn rim of wheel 1 in plate of rolling; x 200

Rim microstructure examination in flow zones showed that the displacement of metal from inclination 1:20 to inclination 1:7 is inexpediently, as far as flowing occurs by layers and it is accompanied by complete turbulent steel stream. It results in increased wear out, occurrence of cracks, laminations and zones of heterogeneous deformation, scabbings, flows on hump retard. Therefore, existing geometry of tread with inclination 1:20 and 1:7 is far from geometrical perfection and it demands further change into curved

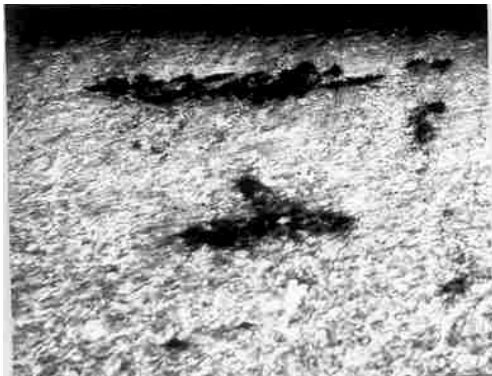
6a

One of the main causes is passing of plastic deviations with significantly great degree of deformation, which has unequal mode. Just at the border of zones with different degree of deformation microcracks, delaminations, wear-out fragments appear (fig. 6a). The so-called "white layer" has increased fragility (fig. 6 b), moreover on its boundary with main structure considerable tensions occur, given by different physical and mechanical properties of zones with different structures. It contributes to crumbling of "white layer" (fig. 6c), therefore it is not practically continuous.

Fig.6 Microcracks and delaminations near tread

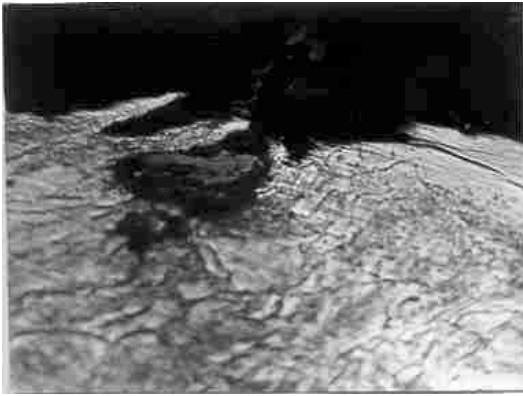
6d

Formation of cracks and wear-out fragments also promotes oxidation and corrosive destruction of tread, at that the oxidation should be referred to formation of rough nonmetallic inclusions on tread. At presence of nonmetallic inclusions in surface layer, which have metallurgical origin, they become stress concentrator. Near inclusions in initial condition increased concentration of tensions already exists [3]. In the process of development of plastic deviations steel grains bend round inclusion (fig. 6d), and it conducts to unequal development of deformation and accumulation of tensions, which conduct to formation of microcracks (fig. 6e) and destruction of the inclusions. Around nonmetallic inclusions at emergency break application significant thermal stresses also arise, which reach critical size and they also are conductive to origination of cracks and wear-out fragments. It

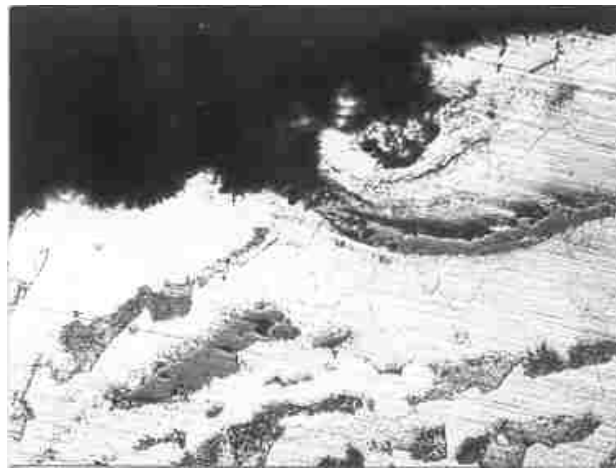
6f

should be noted that nonmetallic inclusions are the center of local decarbonizing of steel which causes to structure inhomogeneity and involves inhomogeneous development of plastic displacement and also formation of microcracks (fig. 6f) and wear-out fragments.

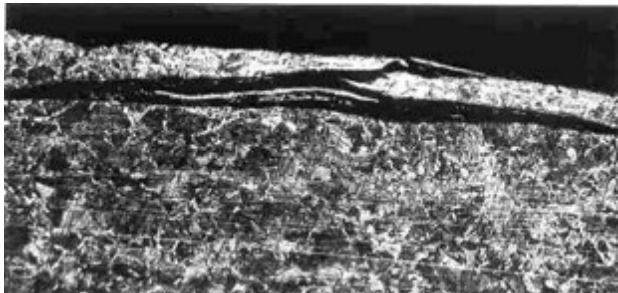
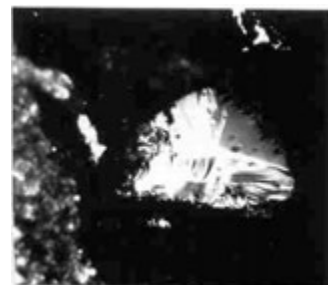
Thus, multiple cyclic thermomechanical influence on tread of wheel at its interaction with rail conducts to accumulation of stresses and defects (microcracks, peelings, laminations) and it leads to formation of fragments of separation (fig. 7a, b). The most spread wear-out fragments are flakes and plates of different thickness. They are typical for normal conditions of wear-out [4] and their appearance connected with plastic deformation. According to theory of wear-out by “exfoliation”, at friction the maximum thickness of dislocation appears directly not at the surface but on some depth where prolonged cracks appear and they grow till critical size forming flakes which are exfoliated. The main part in this process refers to plastic acts conducting to accumulation of dislocations and cracks appearance parallel to the surface. Forming of flakes of wear-out goes by the way of adherent exfoliation.

Fig.7a,b. Wear-out fragments near tread

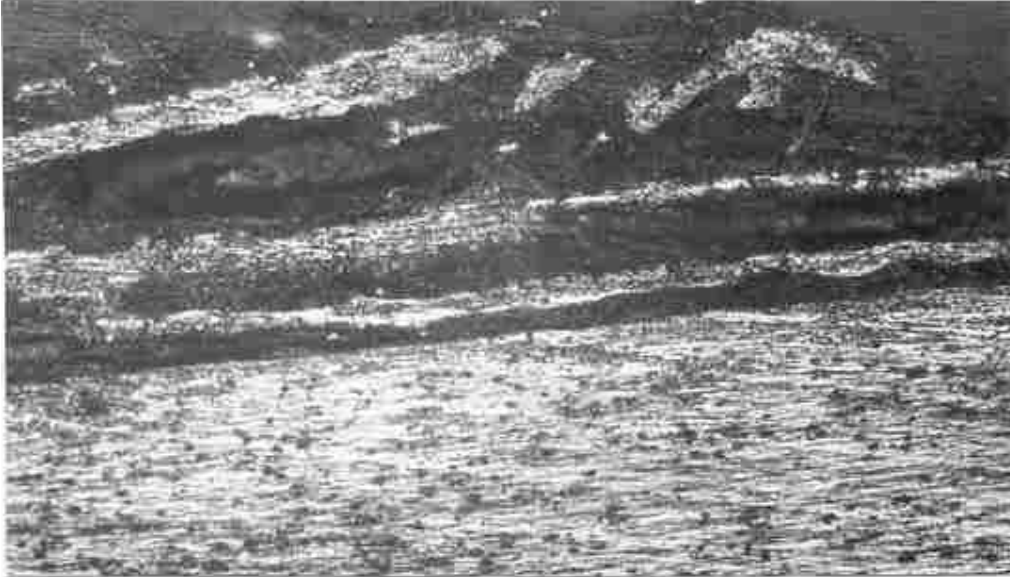
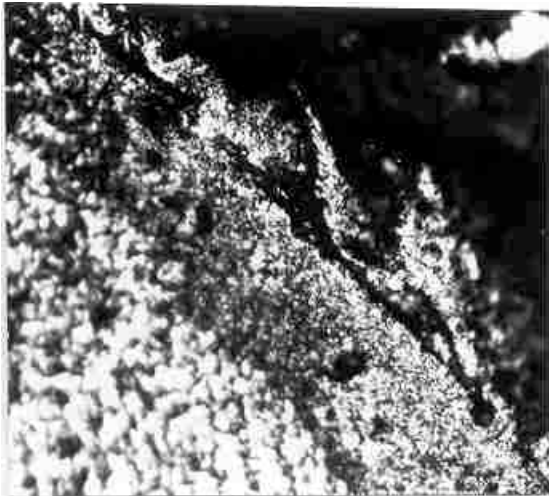
Sometimes wear-out fragments are in the form of loops, curls similar to chips during cutting (fig. 7c). Such fragments precede to damage and they are disclosed mainly on tread before local destruction. Wear-out fragments are also disclosed in the form of splinters with acute edges of irregular form (fig. 7d). Such fragments usually originate at very high pressures and their origin may be connected with forming of small fatigue cracks in surface coats of rims and their coming out on surface is the beginning of forming of wear-out fragments.

Fig.7,c,d. Wear-out fragments near tread

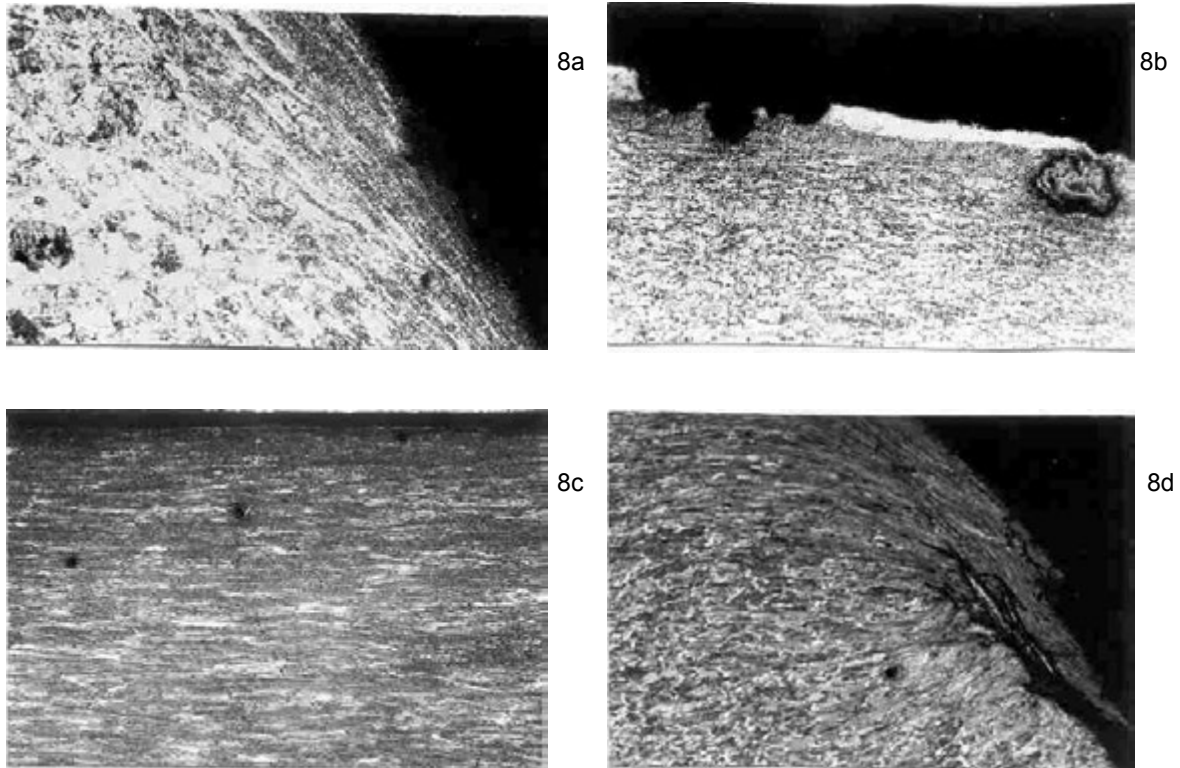
Comparative researches of structural modifications near complex curvilinear tread of wearied rim (wheel #2) were conducted. In the cove zone the grains are elongated and crumbled up (fig. 8a), while coming out on tread surface elongation degree of grains is decreased (fig. 8b). While moving off the middle of tread elongation degree of grains increases again (fig. 8c) and it becomes significant near the edge of rim. Near external side rim border the little flow occurred (fig. 8d), where exfoliation is disclosed, areas of oxidation of steel and microcracks.

Fig.8. Microstructure near tread of worn rim of wheel 2 in the cross section; x200

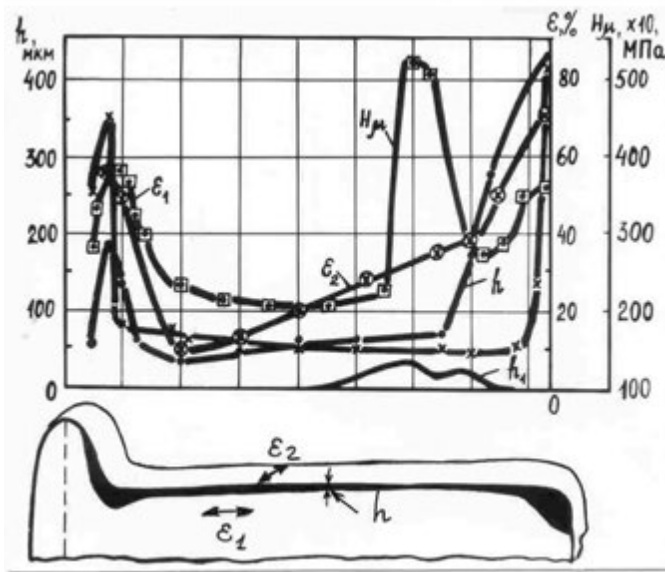
On fig. 9 and table 5 parameters of zone of structural modifications in wheel #2 are mentioned. As of the wheels with plane conical tread, deformation zone innermost spread in the places of coving and flow of wheel #6. The mode of changes of microhardness of steel by width of rim is similar. Sharp jump of microhardness on distance 2/3 of flange width connected with presence of "white layer" zone. The results of definition of dislocation thickness showed that their quantity is also maximum in cove and flow zones (table 5).

Fig. 9. Changing of deformation rate of grains across ϵ_1 and in rolling direction ϵ_2 , microhardness H_μ and depth of plastic deformation area h in the width of wheel rim 2
