SCIENTIFIC
PROCEEDINGS
OF RIGA
TECHNICAL
UNIVERSITY

WEAR ANALYSIS OF WHEELS AND RAILS AT INDUSTRIAL TRANSPORT

A. Śładkowski, T. Kuminek

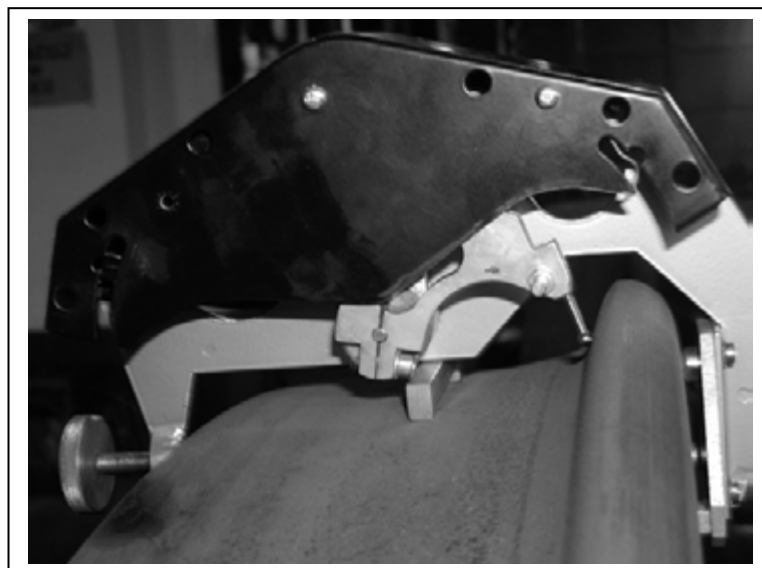
Fig. 1. ‘A-B profilometer’ for railway wheel tyres

The profilometer is made for the purpose of scanning of working profile of wheels with 0,01 mm accuracy and enables recording obtained data in DXF format.

Geometric measurements of wheel working profile were carried by using ‘A-B profilometer’ for railway wheel tyres (fig.1) manufactured by PTU GRAW Gliwice. The ‘A-B profilometer’ is the property of Railway Transport Department in Katowice, Poland.

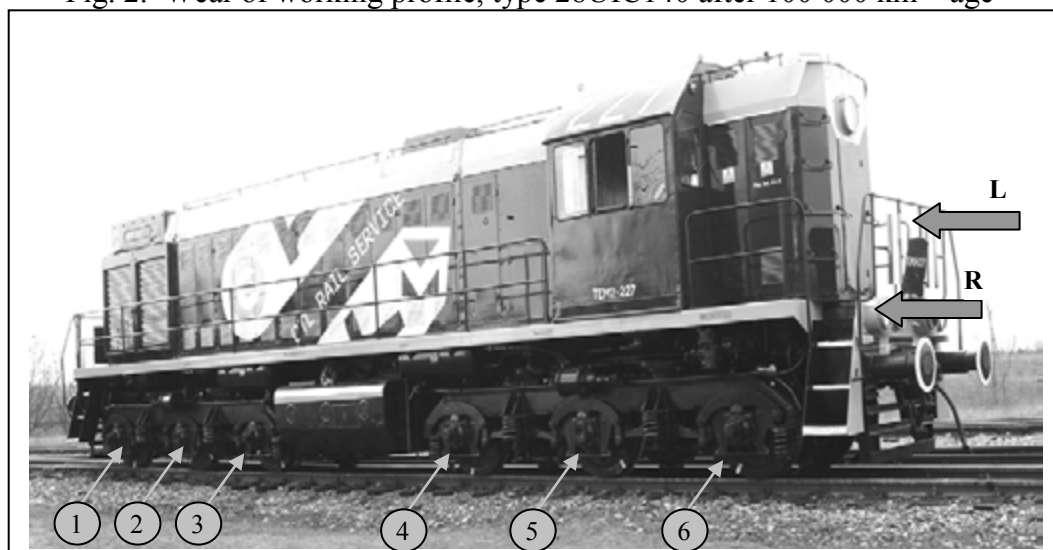
Fig. 3 TEM2 locomotive, as well as distribution and numeration of tested wheelsets

Upon analysis selected wheelsets we can reach the conclusion that the most wearable is external part of the wheelsets: numbers 1 and 6. We can also notice increase of flange height value as a result of the reduction of wheel rolling circle diameter and the decrease of flange thickness and flange slope values as a result of undercutting of wheel flanges. More precise analysis allows us to deduce that the highest increase of the value of flange height concerns wheelset no. 1 and significant decrease of flange thickness concerns wheelsets no. 1 and 6. Average period of locomotive km-age between profile repairs amounts to 2 years approximately, which corresponds to approx. 180 000 km.

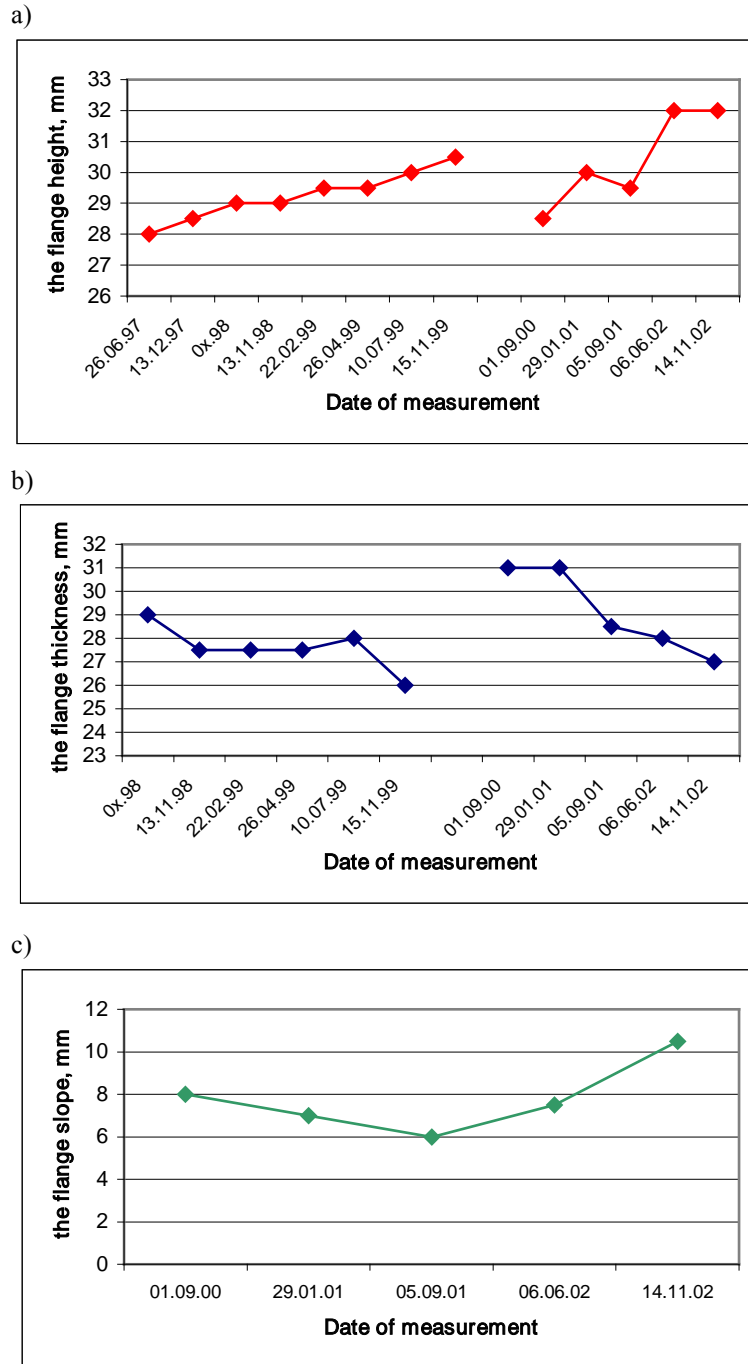
Fig. 4 shows diagrams of wear course of rolling profiles in TEM2 locomotive no. 241. Interruptions in continuity of diagram line mean that the wheelset was turned.

Fig. 4 Examples of the wear diagrams for tyre working profiles in TEM2 locomotive no. 241:
a) The process of changing of the flange height;
b) The process of changing of the flange thickness;
c) The process of changing of the flange slope.

Table 1 and fig. 4 show changes of working profile parameters, which are changeable depending on time only, because km-ages data were not available. Fig. 4c presents flange slope measurements, but only last five ones because of lack of data.
